**DATE: 2/20/2020**

**INVESTIGATOR: Sam Capps**

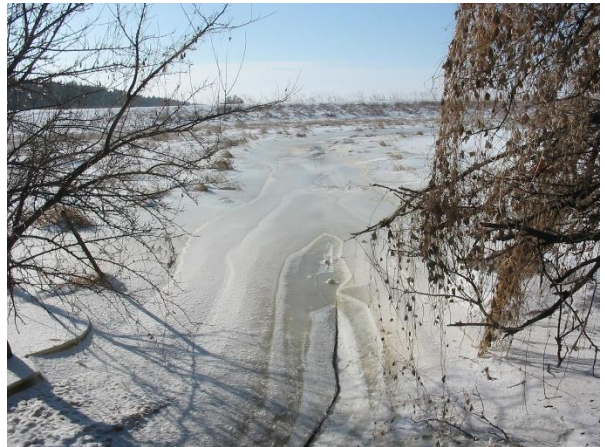
Discolored ice present. Slight thawing occurred since M. Lohnes am trip No significant change from previous report.

Photo: Ice beginning to thaw. Facing upstream.
